Kurt Mitenbuler & Associates, Inc.

Inspection Report prepared for:

Property Inspection location:

Crystal Lake, IL

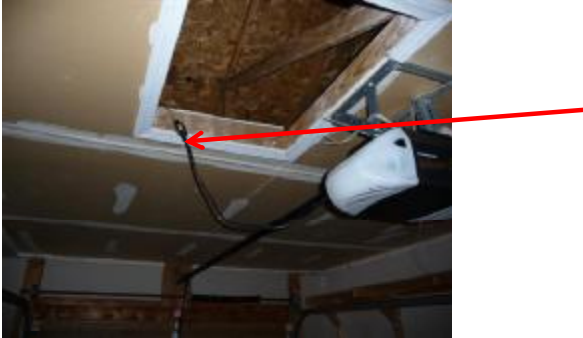
2 The garage door opener outlet at the east door runs into the attic with an extension cord.

There should an outlet installed for the garage door opener so you don't have to run an extension cord into the attic.

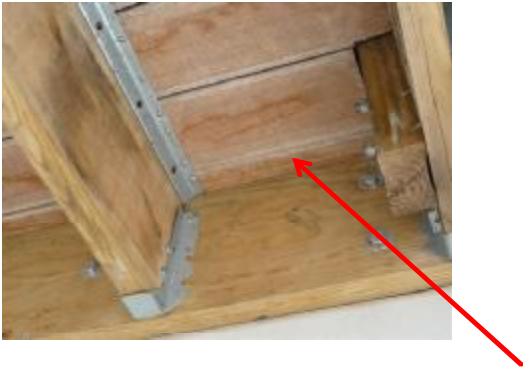
3 There is no visible or apparent flashing @ the rear deck ledger board; this will allow water to leak behind the ledger board and cause the ledger connection to fail. Ledger boards are the most common cause of deck failures; you should install flashing over the ledger board.

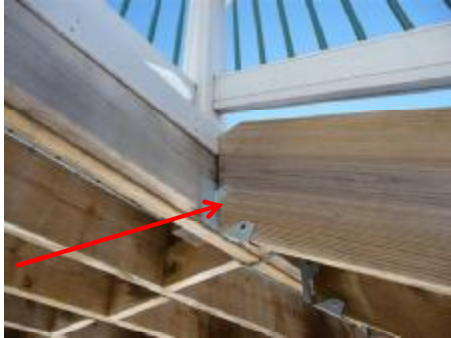
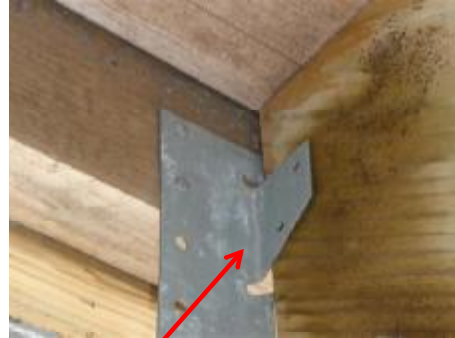
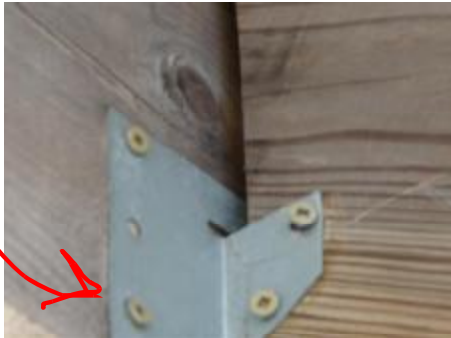
4 The rear porch stairs are not secured to the deck structure satisfactorily. Finish nailing and securing the stairs to the structure with additional brackets and reinforcement.

In addition, the brackets that are in place use screws for securing the hardware; screws are not normally approved for this use. You should only use mfg. approved fasteners for securing reinforcement brackets.

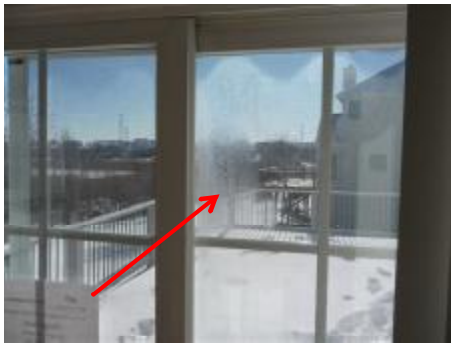
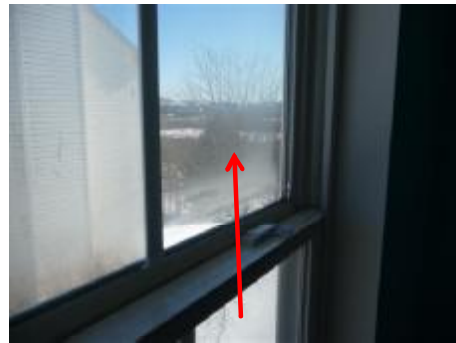
5 The sliding door thermopane is "fogged"; this means the thermopane seal is broken & moisture is condensing between the panes. You should replace the sliding door thermopanes, or better yet, replace the doors.

The 2nd fl. NEBR window thermopane is "fogged", same as the previous comment. The pane should be replaced.

Basically, this sort of cheap vinyl window starts getting a lot of failed thermopanes around 10 years old, which is the age of these windows. You should plan on various window thermpanes failing in the coming years.

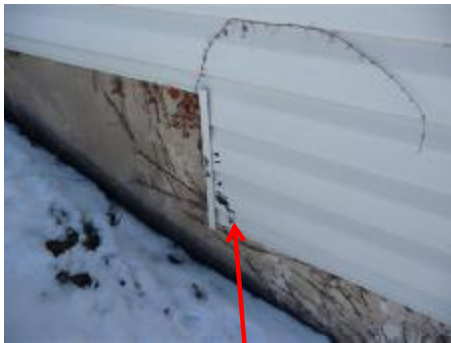
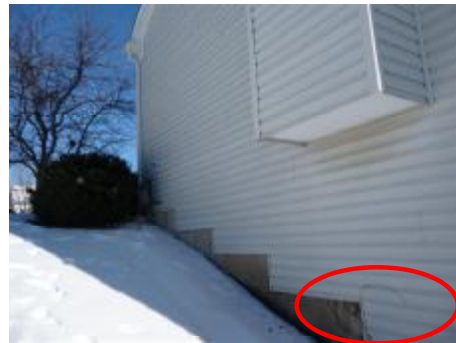
6 There is minor damage to a couple pieces of siding on the west side of the house; repair the damaged siding.

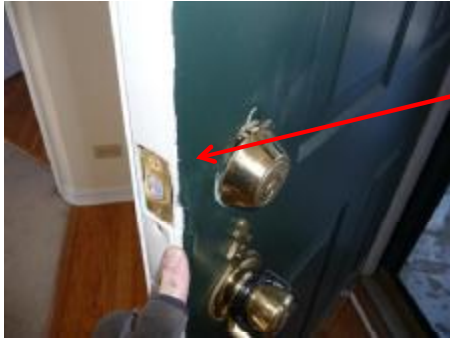
- 7 The front entry door has been mangled by a forced entry. The door should be replaced, as the panels are deadbolts are compromised and may not provide sufficient security.

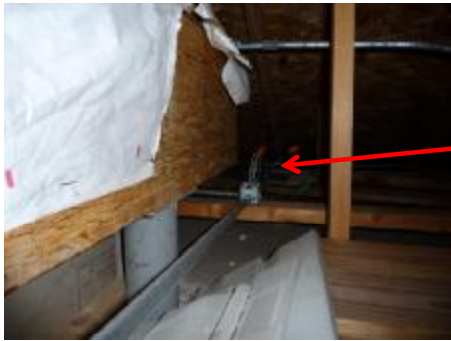
- 9 There is an open junction box in the garage attic. The wires are exposed. The wires should be secured in the junction box, and a cover installed.

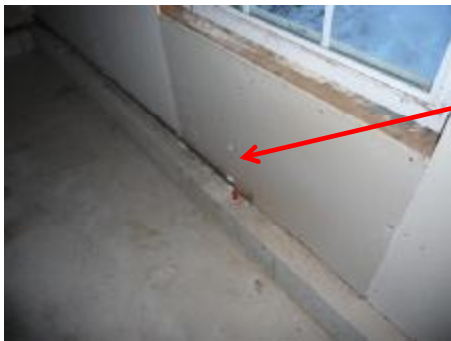
- 11 There is an open, uncapped gas line in the garage. This open line should be capped to prevent accidental opening of the valve which would flood the garage with explosive gas.

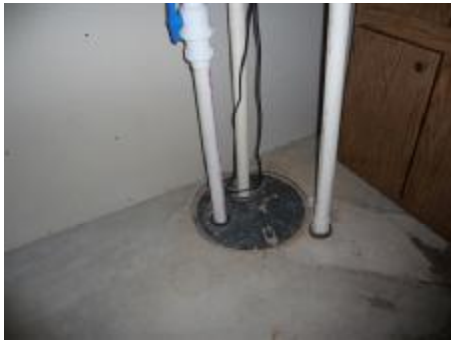
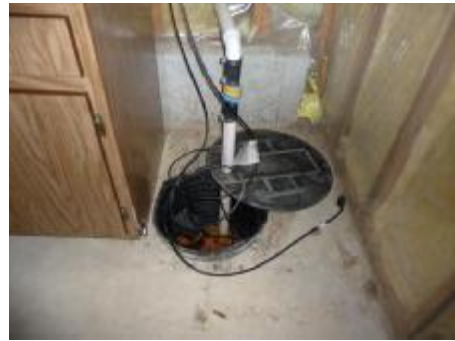
- 12 There are no battery backups or alarms for the bsmt. sumps & ejector system; in the event of a power outage or pump failure, the sumps will backup & flood the bsmt. You should install battery backups and alarms for the bsmt. sump & ejector systems.

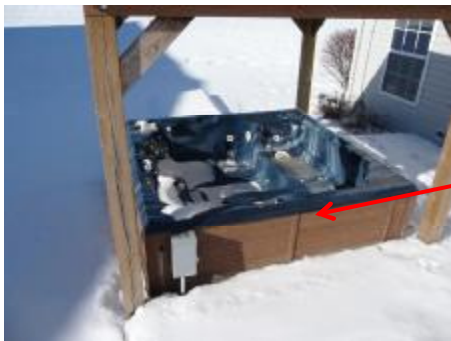
- 14 The hot tub/spa @ the rear yard is not functional. It was abandoned, and it looks like it wasn't winterized. IOW, it's probably junk. Remove it from the site.

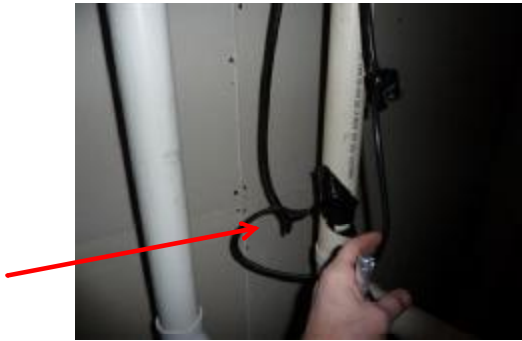
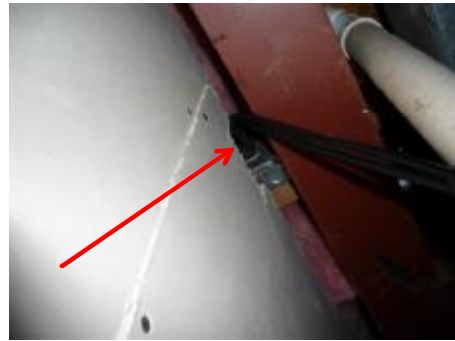
15 The ejector pump wiring is improperly/dangerously spliced, in addition to having the outlet very inconveniently located. Replace the cord wiring or otherwise repair the splices.

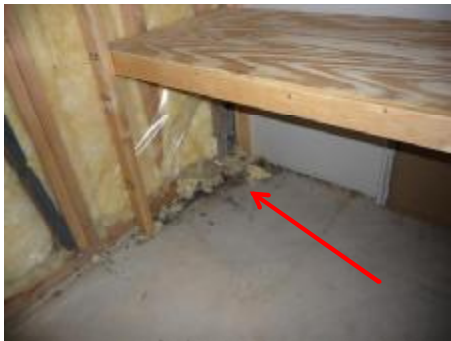
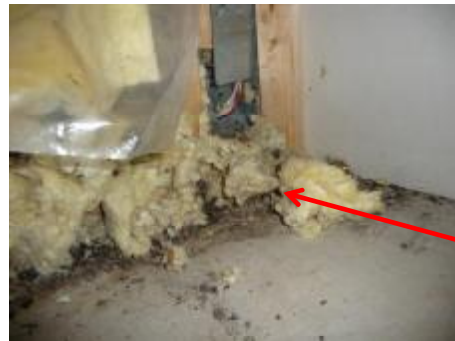
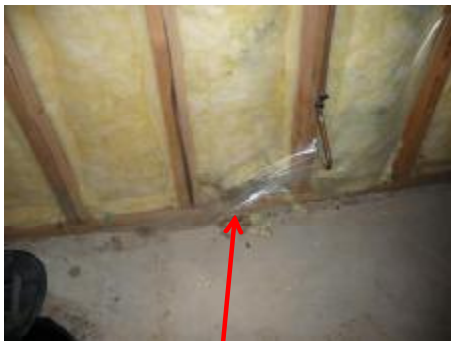
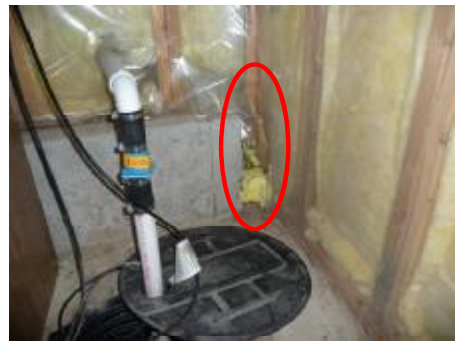
16 There are mouse nests (at least 2) in the bsmt. It looks like they're entering @ the SE corner of the bsmt.

You should seal up the opening(s) that allow the mice in, clear out the nests, and treat the area against future infestation.

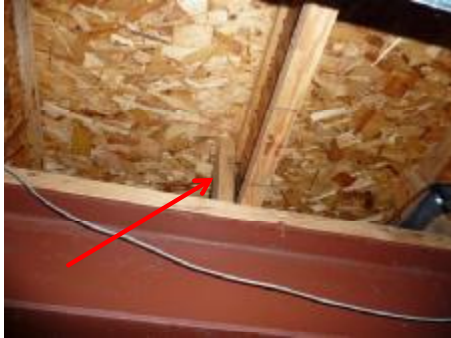
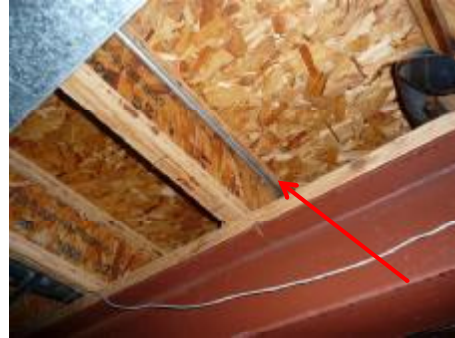
17 There are minimal squash blocks under the bearing walls over the main beam in the bsmt. The lack of squash blocks can cause settlement.

A single block is often approved, but double blocks on either side of the joists is preferable. Install additional blocks as necessary to provide support.

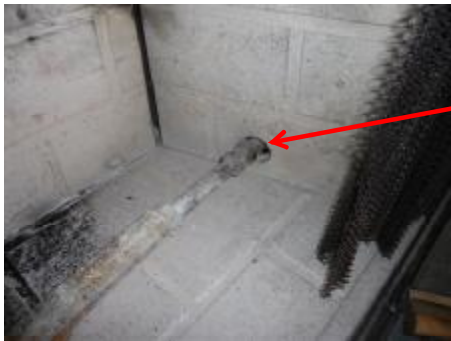
18 The fireplace gas igniter pipe is not sealed where it enters the firebox; this could allow combustion gas or fire to enter the sidewall & cause a house fire. Seal the gas pipe @ the firebox penetration.

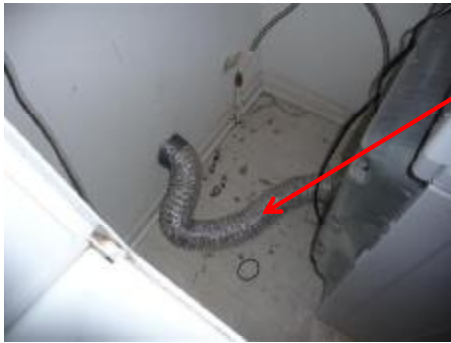
- 20** The laundry dryer vent is plastic foil; this material has been shown in several studies to be a fire hazard. Replace the vent duct w/smooth walled metallic ducting.

This has become very common, even w/well documented problems w/the foil type vents. You might want to review the information @ this site....

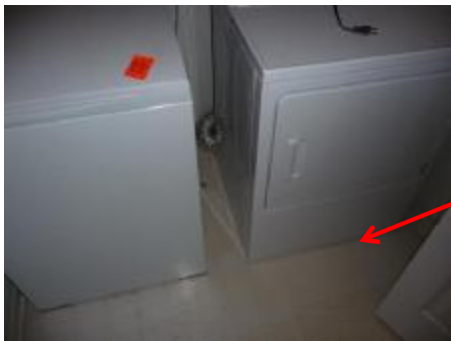
- 21** The washer isn't installed on a drain pan; if the washer leaks, it will flood the house. You should install a drain pan under the washer & connect it to a drain.

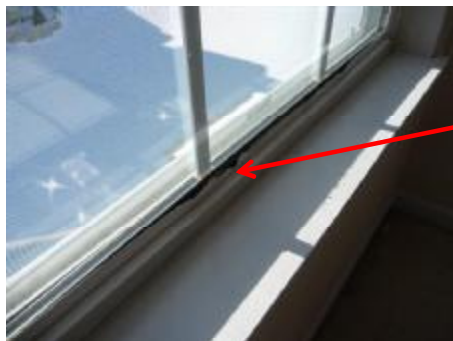
- 23 The MBR west window handle is damaged / not critical, but FYI.

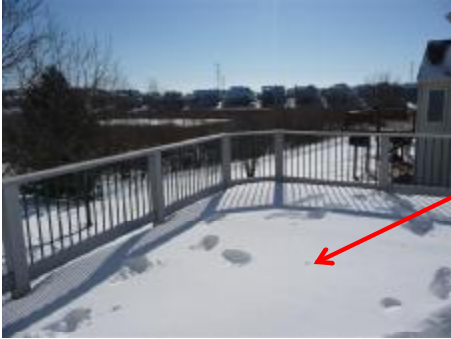
- 25 The deck was completely snow covered. I couldn't inspect it satisfactorily.

Reinspect the deck after the snow has melted.
