Kurt Mitenbuler & Associates, Inc.

Inspection Report prepared for:

| House/Building Type: | Masonry 3 flat |

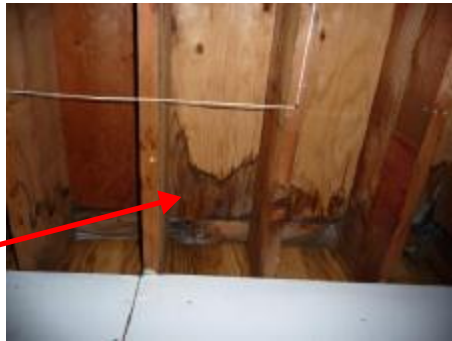
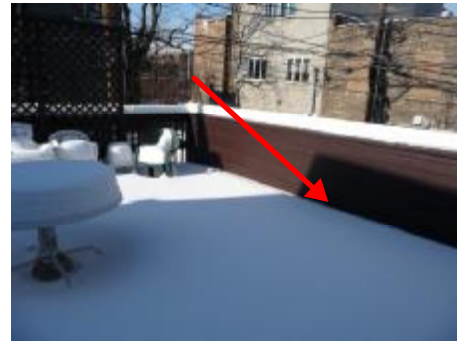
Garage

1 There is a roof leak along the east eave; it is rotting the roof sheathing.

I can't tell exactly where it's leaking due to the snow load.

Repair would mean removing the deck to provide; this by itself is a major expense.

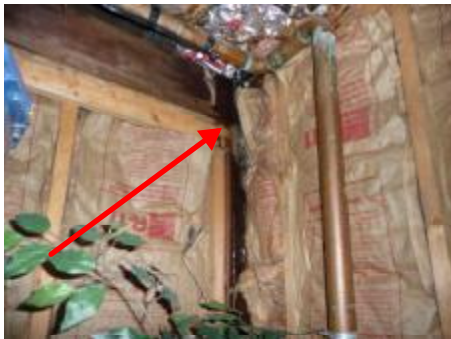
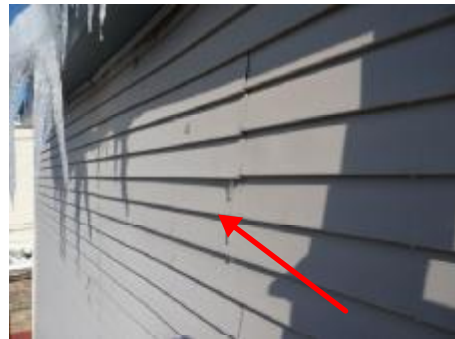
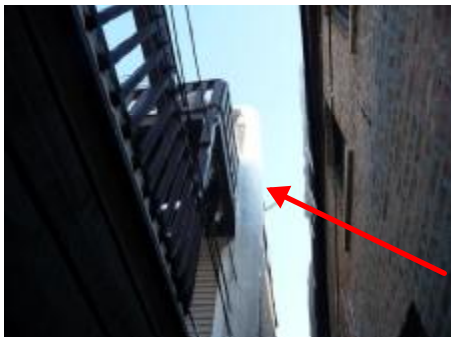
Deck / Porch

- 5 Water was leaking in through the walls and windows at the rear porch due to the huge ice dams on the rear eaves. Water is backing up in the gutter and running down through the wall. This is partly due to the lack of flashing and partly due to the ice dams.

This will rot out the wall. The roofing and wall flashing should be repaired so the wall doesn't leak.

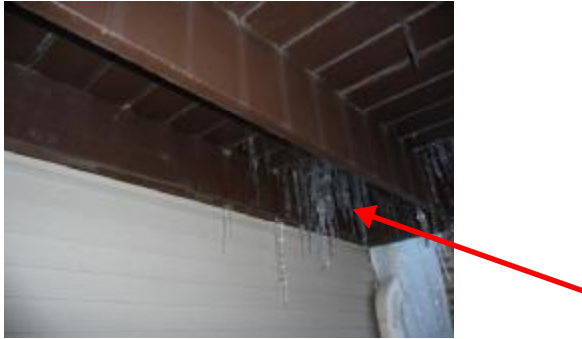
Deck / Porch

- 6 There is no visible or apparent flashing @ the rear deck ledger board; this will allow water to leak behind the ledger board and cause the ledger connection to fail. Ledger boards are the most common cause of deck failures; you should install flashing over the ledger board. See previous comment.

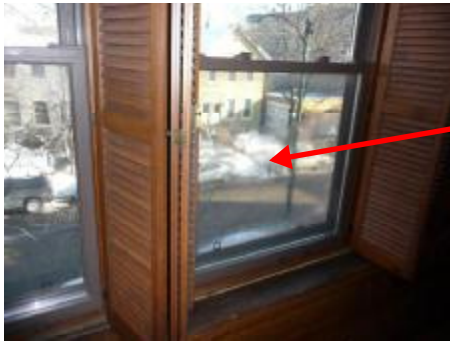
Sidewall

- 7 The LR middle window pane is "fogged". This means the thermopane seal is broken & moisture is condensing between the panes. You should replace the thermopane.

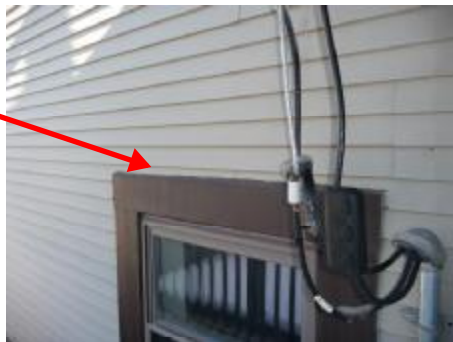
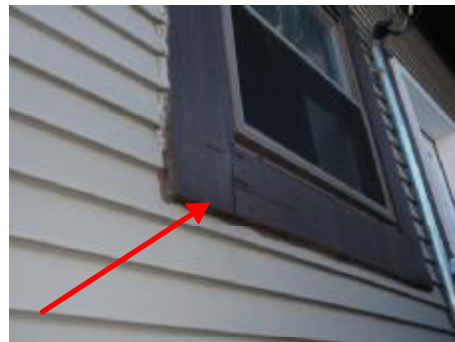
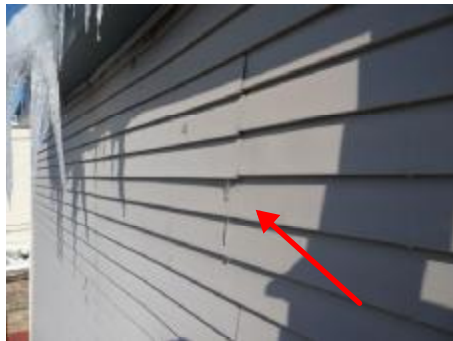
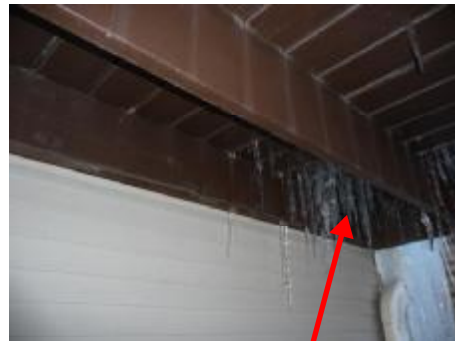
Sidewall

8 The rear porch windows lack drip caps. This means they can leak. The wood trim is decayed in one window, meaning they've been leaking.

Water and ice were running out from under the siding at the time of the inspection; this is an indication that there are leaks. Leaks mean damage.

Install drip cap flashing over the windows.

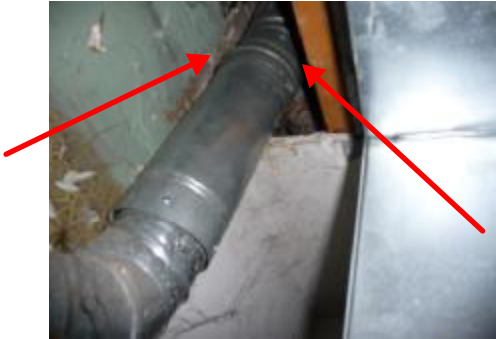
HVAC

- 9 The B vent for the 1st fl. furnace is in contact w/combustible material (wood lath, framing) behind the furnace. Since the flue pipe is hot, it could start a fire. Mfg's. spec's state there should be a minimum 1" clearance to combustibles.

Repair the vent to provide minimum clearance for fire safety. This could be a complicated and expensive process.

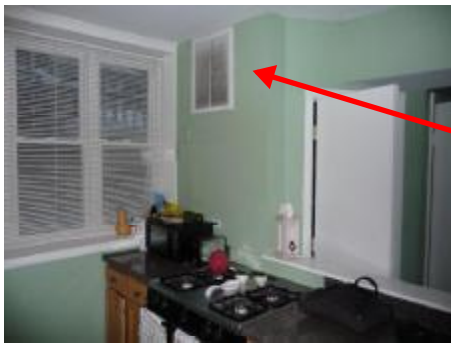
HVAC

- 10 The 1st fl. air return is in the kitchen and directly above the kitchen range. Combustion gas from the stove can be drawn into the system and distributed through the unit. In addition, grease and contaminants from the stove will be drawn into the furnace which can damage it.

All model building codes prohibit having return air in the kitchen. Repairing this means the ducts would have to be moved which is a major expense.

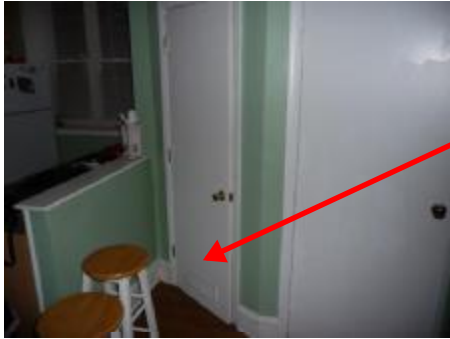
HVAC

- 11 The combustion air intake for the 1st fl. furnace is unsatisfactory. It utilizes a single air intake instead of "high-low" vents that provide even air distribution. Install additional high/low vents as necessary to satisfy the combustion air requirement for this furnace.

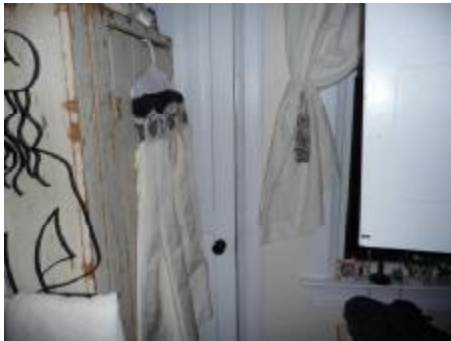
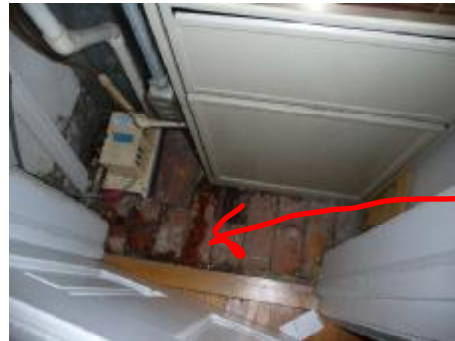
HVAC

The 2nd fl. furnace was not accessible due to furniture in front of the closet. While I wasn't able to do a complete inspection due to lack of access, I was able to see several defects, including but limited to:

- 1) The furnace is in the BR. Furnaces aren't allowed in BR's unless it is a Category IV, and the door is sealed. This is a category IV furnace, but the door isn't sealed.
- 2) There is a puddle of water running out from under the furnace. This can mean several things, all of them critically important.
- 3) There is no redundant drain pan under the furnace as there should be. If the furnace leaks (as it's doing now), it can flood the building.
- 4) There are openings in the furnace closet to the building structure; the closet should be sealed by repairing the plaster.
- 5) The furnace may be old; if it's old, it's going to need replacement in the near future.

Basically, this furnace has to be repaired or replaced. Get a heating contractor in there, provide access, and have them tell you what the repair is going to cost.

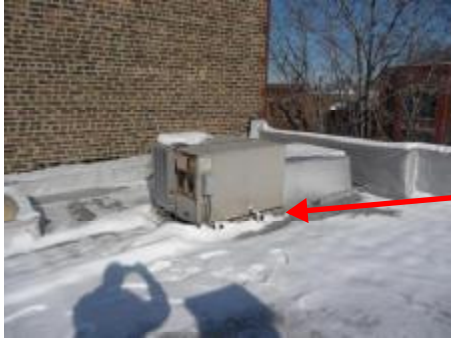
HVAC

- 13 The top floor heating system (located on the roof) is ancient. It's so old the rating plate is worn away so I can't even read the serial #'s. This sort of equipment usually lasts about 15 years, then it has to be replaced.

Replacement usually costs around \$15,000 for this type of equipment.

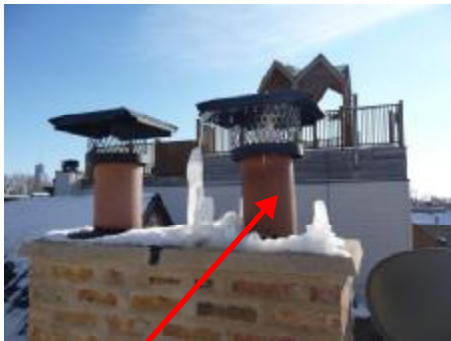
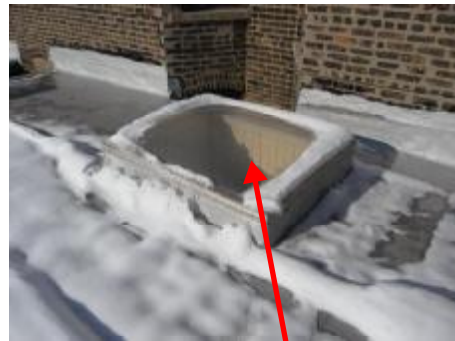
HVAC

- 14 There are no metal liners for the boiler & water heater chimneys; liners are necessary to keep moisture from condensing on the chimney interior and causing damage through freeze/thaw cycles. You should install metal liners in the chimneys.

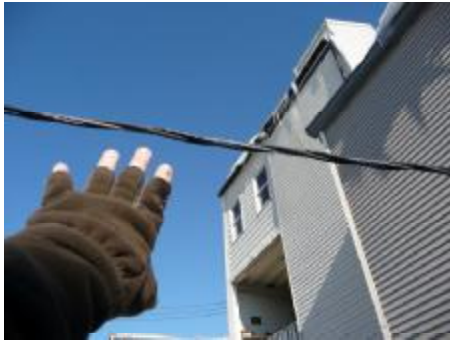
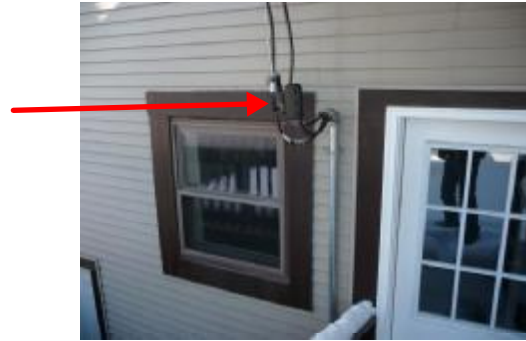
Electrical

- 15 The electrical service is too close to the rear deck. The service should be minimum 10' above the deck, and/or 3' outside the footprint of the deck space. There should be this minimum clearance to prevent occupants from touching the service and possibly being shocked or electrocuted. You should install a nonconductive barrier between the deck and the electric service to prevent accidental contact.

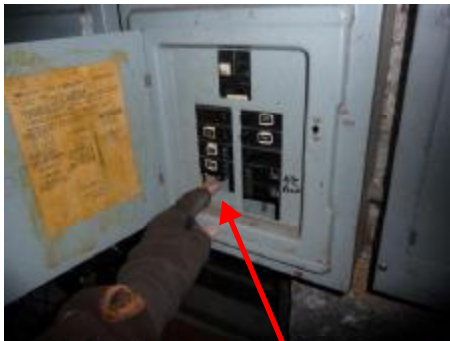
Electrical

- 16 There are open knockouts @ the 2nd fl. panel; the open knockouts could allow insertion of fingers into the panel interior, resulting in electrocution or severe shock. Cover the open knockouts w/knockout covers.

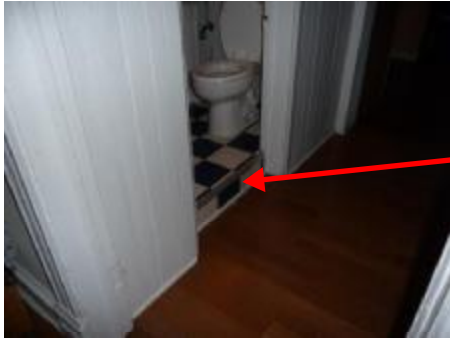
Plumbing

- 19** The 1st fl. bathroom is set on a "raised floor". This practice usually hides poor plumbing practices; the floor is raised so that non-standard connections can be obscured. I can't tell for sure what's going on until the floor is torn out.

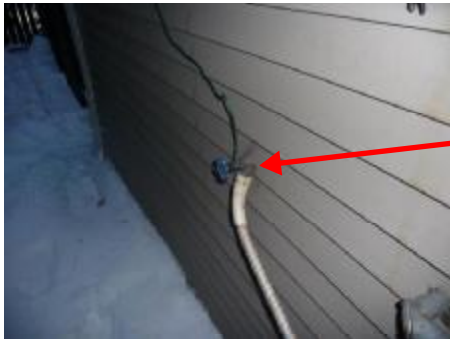
Plumbing

- 20** The exterior hose faucet is not a freeze proof type. This means it can freeze in winter. If it freezes, it will burst, and it could flood the house and damage the home.

I couldn't find a valve to shut off the hose faucet. You should ask the seller if they know where it is. If there isn't one, you should have one installed. Every winter you should shut the valve off before freezing weather to avoid freezing & bursting pipes.

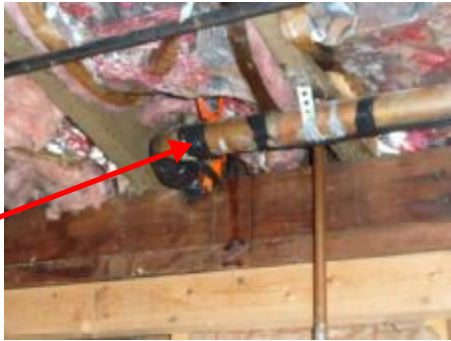
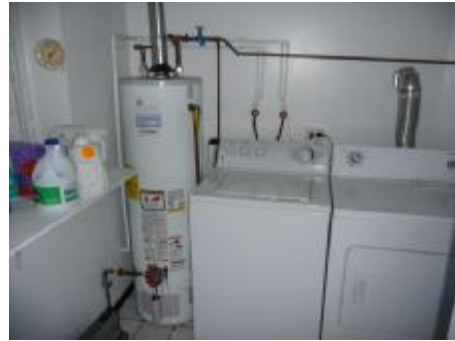
Plumbing

21 The rear 2nd fl. laundry has pipes exposed to freezing.

There are deicing cables on the drains under the rear porch, and there were two signs on the laundry door warning of frozen pipes if it gets too cold. If the pipe freezes, it will burst & flood the property.

You should relocate the pipes so they are on an interior wall, and heat the area under the rear porch so the pipes don't freeze.

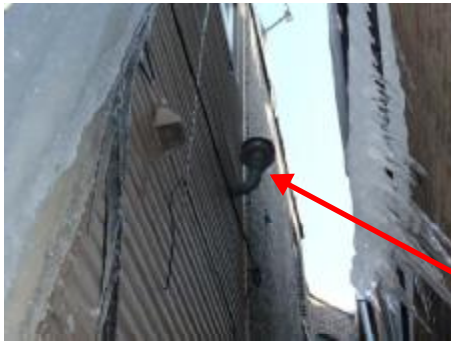
Plumbing

22 The rear laundry water heater vents through the wall. This sort of vent isn't approved for through wall applications. It could fail and cause combustion gas to back into the house.

The water heater should be vented conventionally, or a new water heater installed that is approved for thru wall venting.

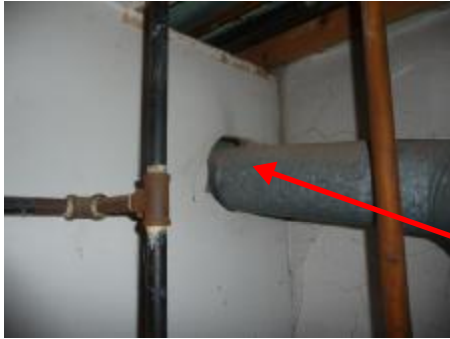
Plumbing

- 23 The bsmt. water heater flue is in contact with combustible material. It's hot and could start a fire. The flues should be reconfigured when the furnace flues are repaired.

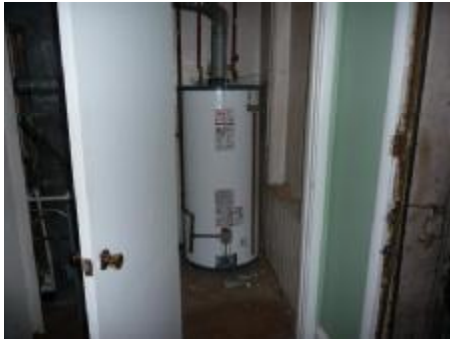
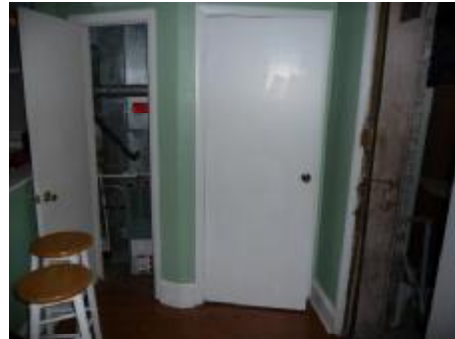
Plumbing

- 24 The lower level water heater closet lacks combustion air vents. This can cause the water heater to malfunction dangerously.

Install combustion air vents in the water heater closet door.

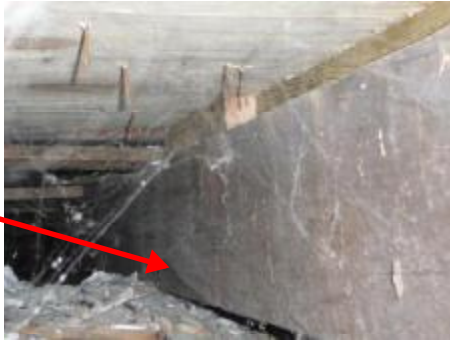
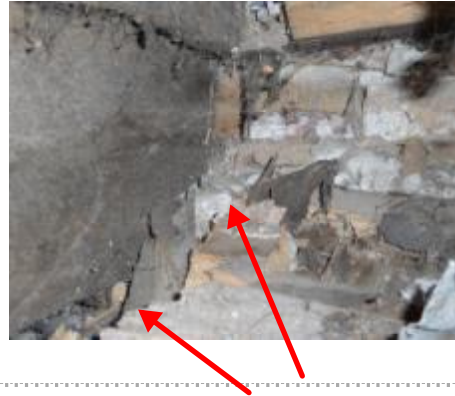
Structural

25 There was no access under the 1st fl. There is an air space down there, but it is not accessible.

The concern is there is wood in close proximity, or in contact with, the dirt under the building. Wood in contact with the earth is highly susceptible to termites. Since there is no access, you would never know if there were termites until there was substantial damage.

You should have a preventative treatment on the property, since there is no way you can perform a satisfactory inspection that would reveal termites (due to lack of access).

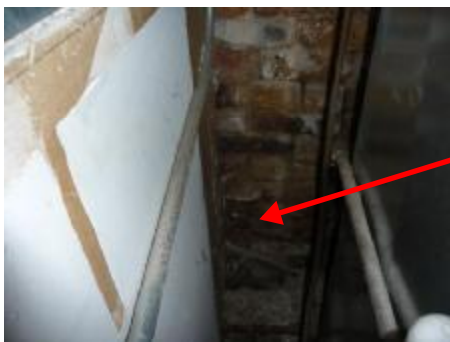
Structural

26 The only area of visible foundation was located in the lower level mechanical room. What little I could see showed a damp foundation with wood framing up against it.

I've seen enough of these to know what's under the drywall. It's always damp and moldy. This is conducive to termites in addition to mold, rot, or structural damage.

There isn't any way to repair this without tearing out the interior finishes so vapor barriers and moisture control systems can be installed.

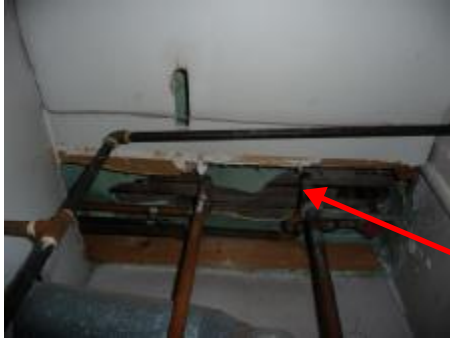
Structural

27 There are areas of the bsmt. ceiling lacking plaster or drywall. There should be a fire separation of plaster or drywall to prevent fire in the bsmt. from engaging into the upper floors.

Patch and repair the bsmt. ceiling to provide a continuous plaster or drywall fire separation between the bsmt. and the upper floors.

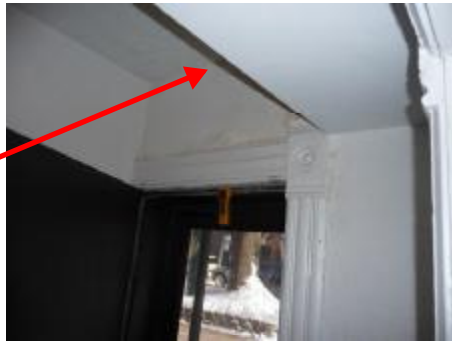
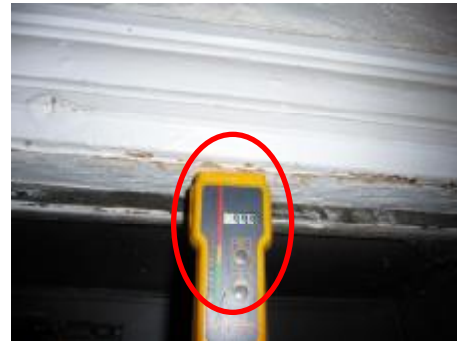
Interior

28 The 1st fl. entry door head jamb is wet and water stained. Moisture content was @ 99% meaning saturation. The water is leaking in around the porch threshold for the upper floor entry doors.

Since the area was ice encrusted, I couldn't tell the specifics. Repairing this sort of problem satisfactorily means more than applying wads of caulk. You will probably have to remove portions of the porch so flashing can be installed.

Get the area deiced and thawed, and I can tell you how to fix it. Until then, all I know is it's a problem.

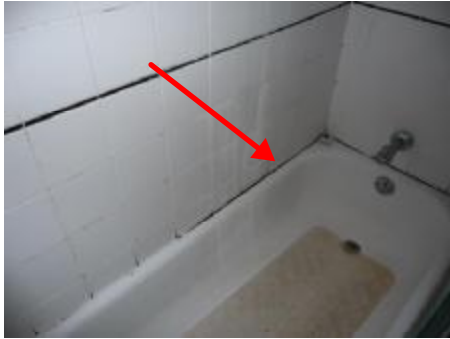
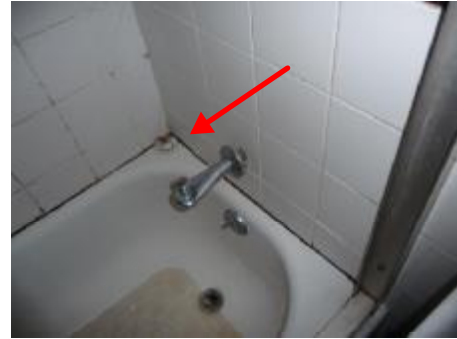
Interior

- 29** The top floor bathroom shower tile is mold, loose, and in poor condition. The shower tile should be repaired or replaced.

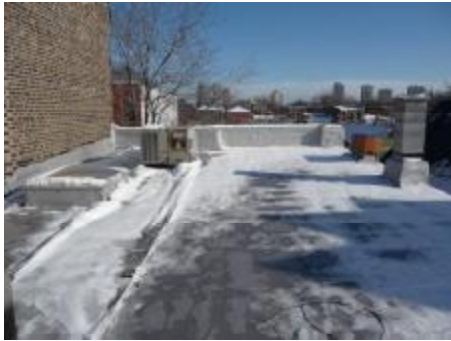
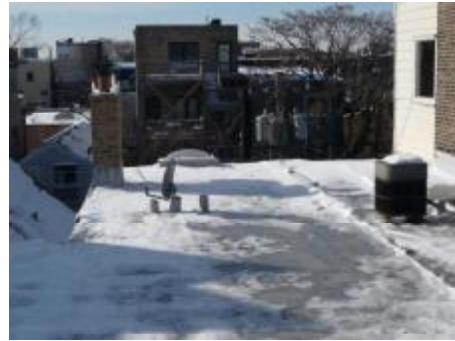
Roof

34 The roof was entirely snow covered & inaccessible for inspection.

? You should have the roof reinspected after the snow has melted to determine it's condition.

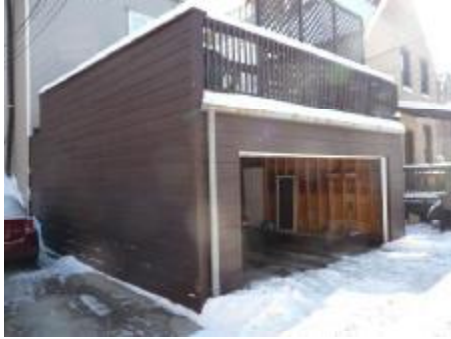
Structural

- 37 The garage roof deck may not have engineering overview or approval. All decks and porches have to have City approval.
- Verify that there is architectural or engineering approval for the rear garage deck, as the structure may not be adequate to support the loads. That means it could fail under load. You have to verify that there are permits and approvals for the garage roof deck.
