# Kurt Mitenbuler & Associates, Inc.

Inspection Report prepared for:  
**Brawnski Armstrong**  
7505 W. Brown #2K  
Forest Park, IL 60130

Property Inspection location:  
**304 South Home**  
Oak Park, IL

<b>Date Ordered:</b>	May 21, 2008			
<b>Inspection Date:</b>	May 27, 2008			
<b>Inspection Time:</b>	9:00 AM			
<b>House/Building Type:</b>	Masonry 2 flat			
<b>Approx. Age:</b>	85-90			
<b>Payment Record</b>	Amount	5/22/08	\$525.00	<b>Balance \$0.00</b>
	Payment	5/28/08	-\$525.00	
<b>People Present at Inspection:</b>	<b>Weather /Temp. &amp; Conditions</b>			
Buyer	45-50 Degrees Fahrenheit			
Seller	Overcast			
Tenant/occupant	High wind

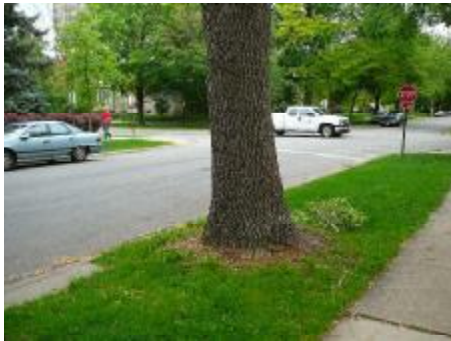
- 2 Trees in the parkway may be putting roots into the tile sewers. You should have the sewer rodded & videoscoped to verify its condition / see also Plumbing.

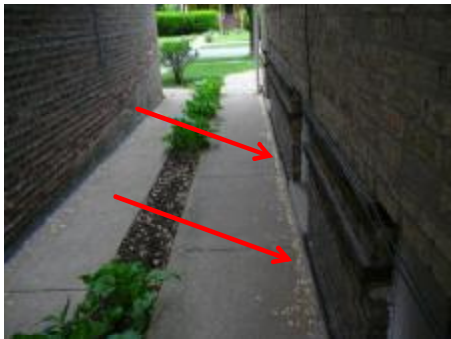
- 3 The south walk pitches toward the house. This will hold water against the house which greatly increases the possibility for bsmt. dampness or water entrance. You should replace the sidewalks, or do other improvements to divert water away from the house.

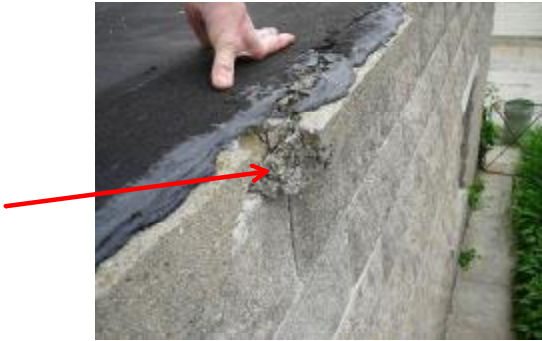
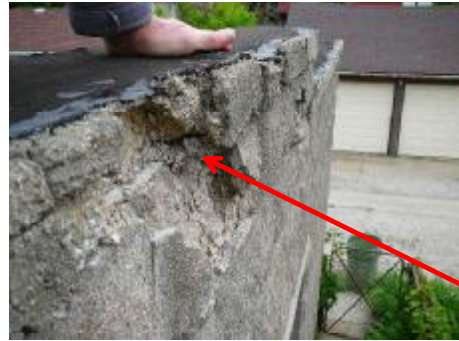
- 4 The garage masonry parapet is falling apart around the perimeter. Some of the masonry could fall and injure or kill someone.

Repair all the garage parapet walls.

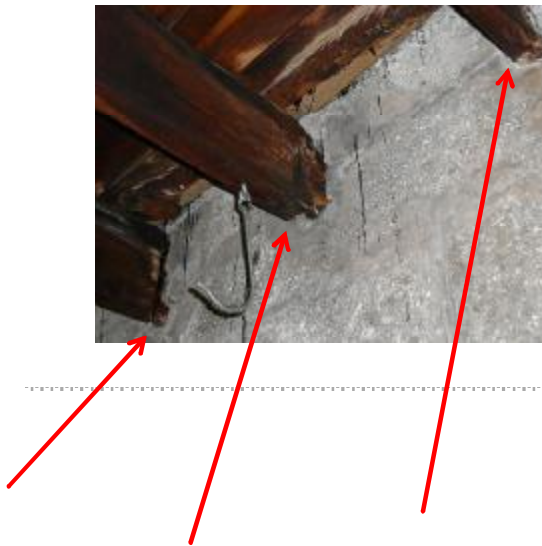
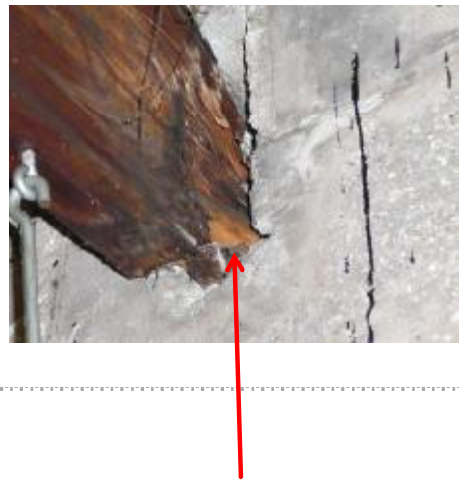
- 5 The south garage bay roof joists are rotting badly where they bear on the exterior wall joist pocket. The joists could collapse.

Repair the joists by replacing them or installing reinforcement.

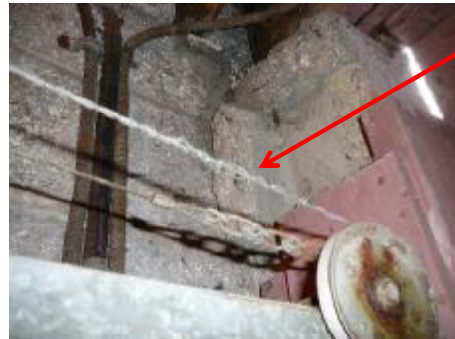
- 6 The north garage door is off it's track and the cables are worn are about to break. The north garage door should be repaired or replaced.

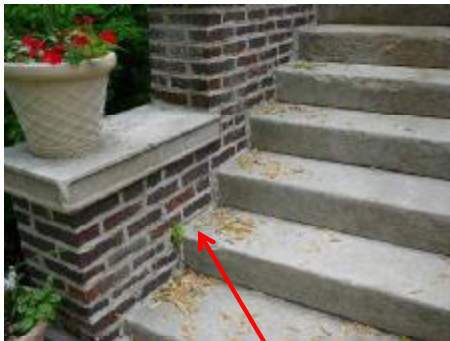
- 7 The front porch north cheek wall has loose brick, and there are leaks between the stairs and the cheek wall.

Repair the porch to keep water out of these side cheekwalls.

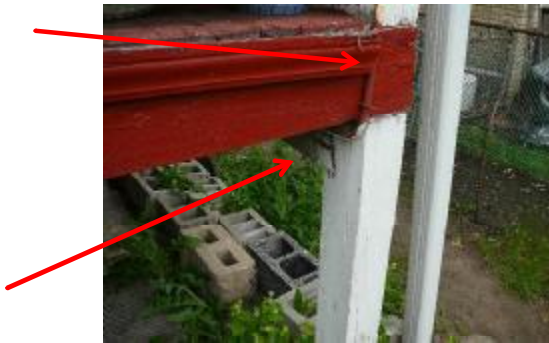
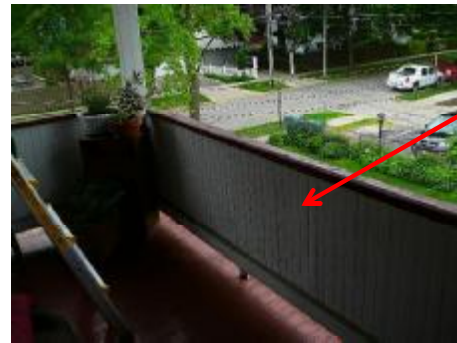
8 The rear egress porch has defects that could cause failure or collapse, including but not limited to;

- 1) The horizontal girders are not secured to the vertical supports w/steel connectors.
- 2) The stair stringers are not secured to the porch framing w/steel reinforcement.
- 3) The posts are not secured to their footings w/galvanized clips. This could allow the posts to shift and cause settlement or failure.
- 4) The guardrails are <42". This could allow occupants to fall over the railing.

The porch could use repairs or improvements. Have a porch contractor look at the porch and provide an estimate for repair.

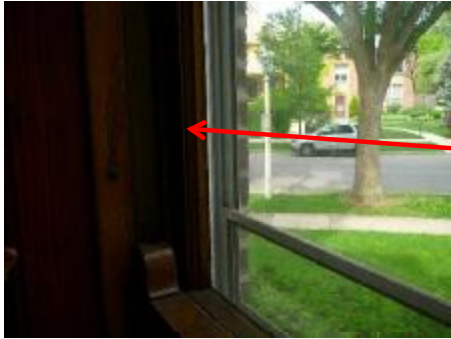
- 10 Several windows were lacking sash cords to hold the sash up. Repair the sash cords.

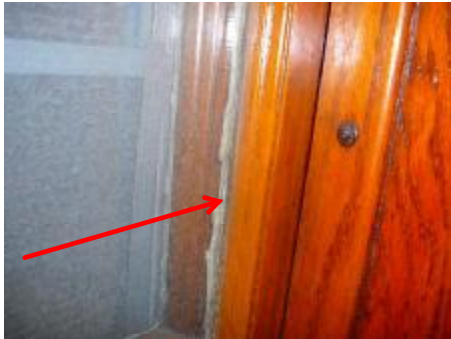
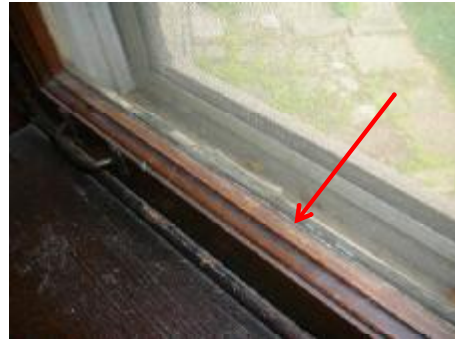
- 11 The windows all need reglazing. Nearly every window had deteriorated glazing. The windows were peeling paint.

The windows should all be reglazed and repainted.

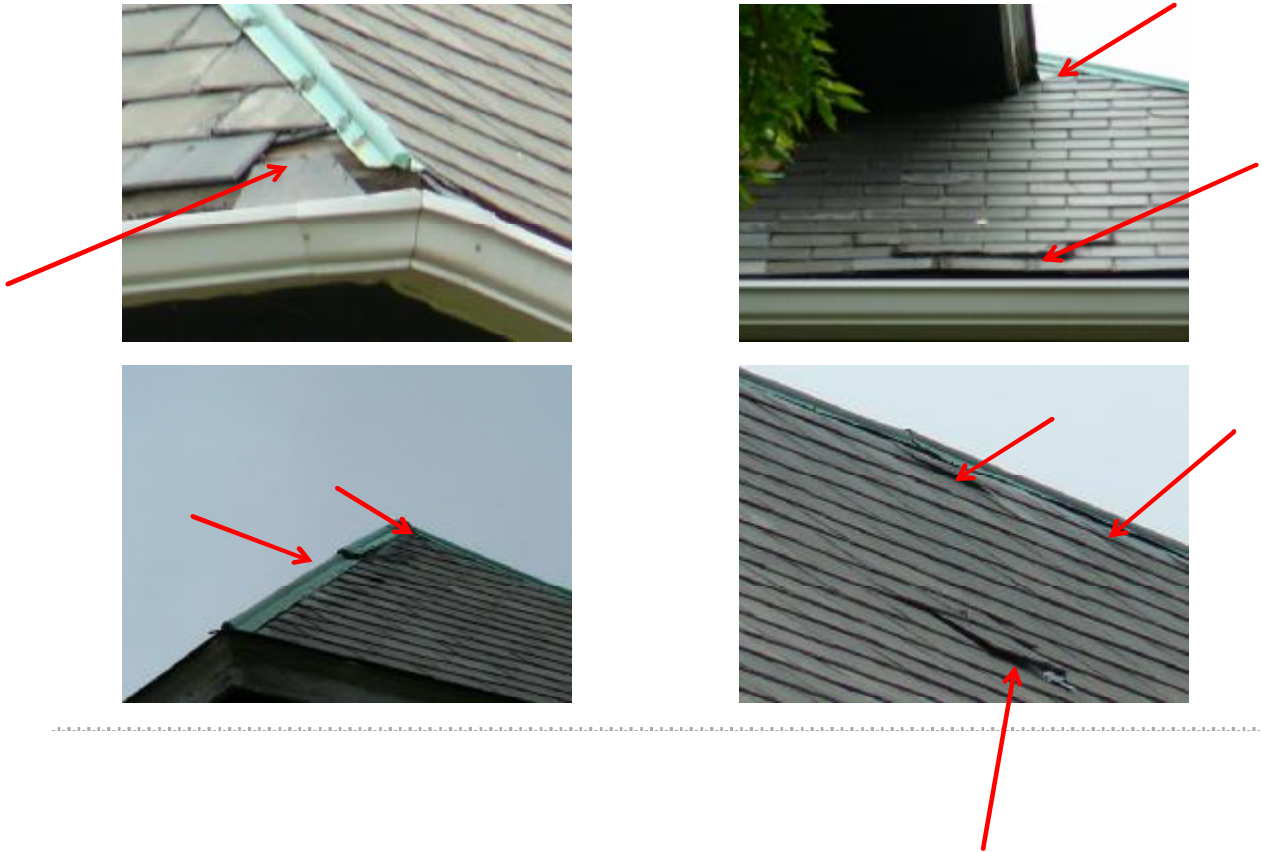
The slate roof is old, and it has problems. There are cracked, broken, and missing slates. The slate is old, and these defects are going to increase w/each season. The flashing is old, the hip covers are loose and nearly blowing off, and the chimney flashing is a mix if tar, copper, and improvised solutions.

In a nutshell, this roof need repair, and the repairs are going to be expensive. Slate repairs are expensive in the first place, but this is a steep roof, and there is no way to work on it without setting up staging and scaffold, and that greatly increases cost.

You could replace it w/asphalt, but the historical commission might require slate. You need to ask the historical commission what they are going to require in the way of repair or replacement.

Get a slate roofing contractor out to this house right away to determine the cost of repair. This could be a very expensive roof.

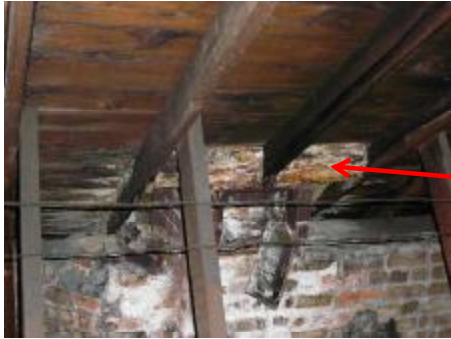
- 13 There are indications of massive leaks around the ENE chimney and in other areas of the attic. The photos don't show the problems particularly well, but you were up there and you saw them. The roof has leaked, and it will leak again because there were never adequate repairs made.

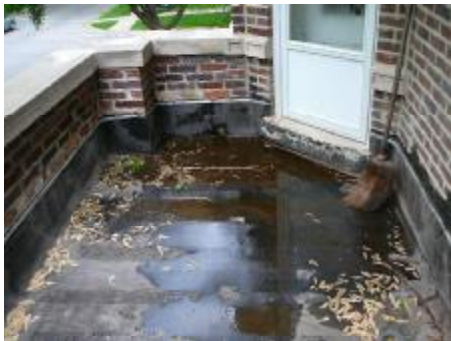
- 14 The front porch roof ponds water. There is no manufacturer of this membrane that approves their material for ponding conditions. Ponds cause leaks.

Repair the front porch roof to drain.

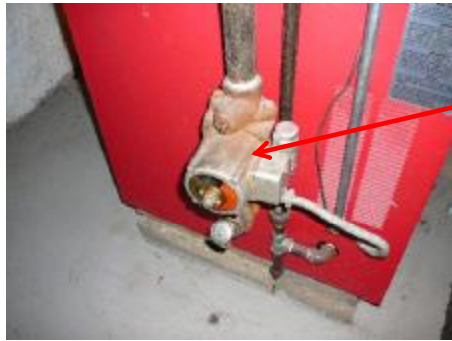
**15** The 1st fl. circulator isn't functional. It wasn't circulating hot water to the radiators.

Replace the circulator.

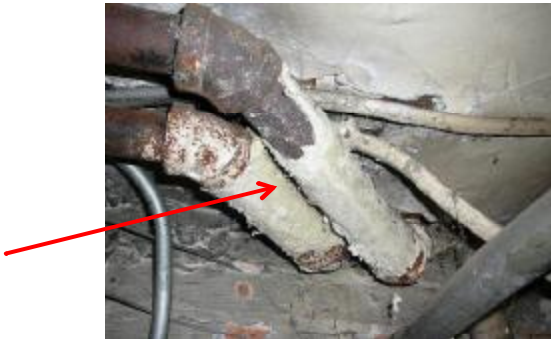
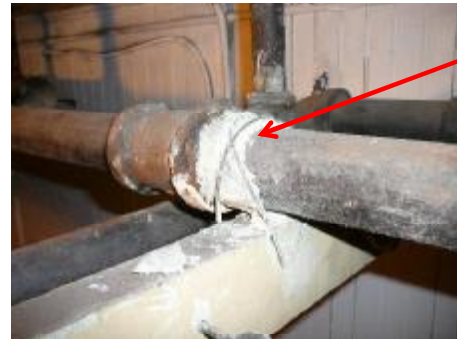
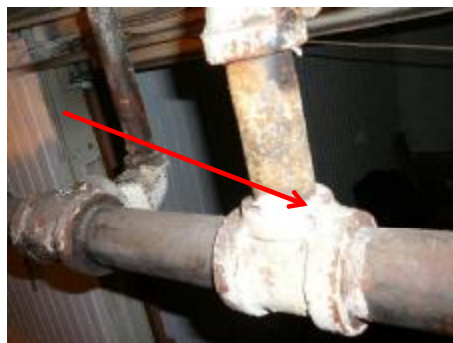
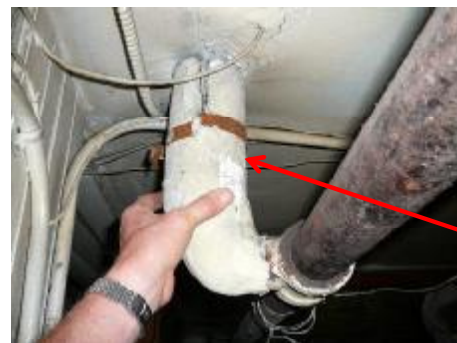
- 17 There are (what look like) scraps of asbestos on some of the pipes in the bsmt. The asbestos should be reinspected by a licensed asbestos abatement contractor and all the material removed or encapsulated as necessary on the best advice of the contractor.

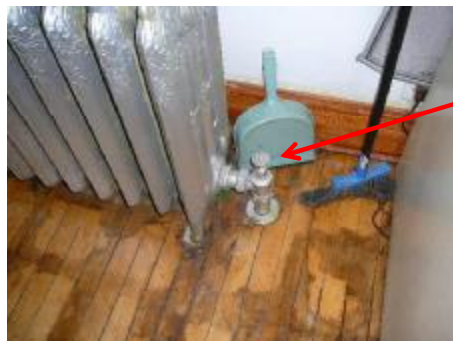
- 18 All the radiator valves are stuck in the open position. This isn't critical, but noteworthy; if you have to perform service on the system, you have to drain it all down instead of simply isolating radiators by shutting them off. This results in higher than necessary repair costs due to the extra work of draining down the system. You should repair the valves as necessary to work properly.

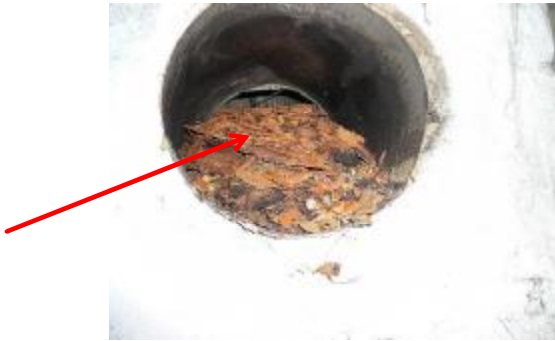
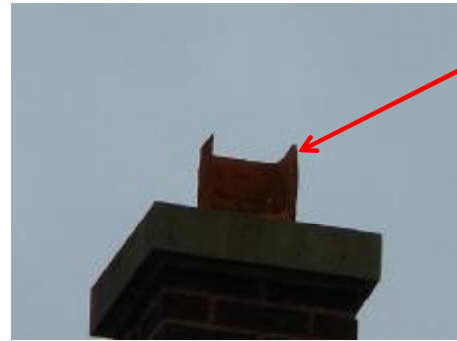
- 19** The east flue is blocked w/chimney liner shards. This could block the flue and cause combustion gas to back into the house which is a life safety hazard. Clean out the flue and install a complete metal liner to prevent future occurrence.

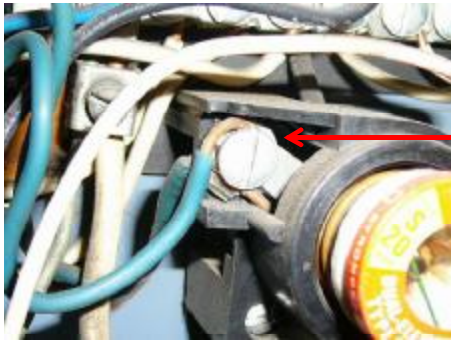
- 21 There is a double tap in the 2nd fl. panel; this means there are two wires attached to a single fuse. Double taps are prohibited because they create the chance for a loose connection that could get hot & start fire. You should repair the double tap so that each fuse only has a single wire connection.

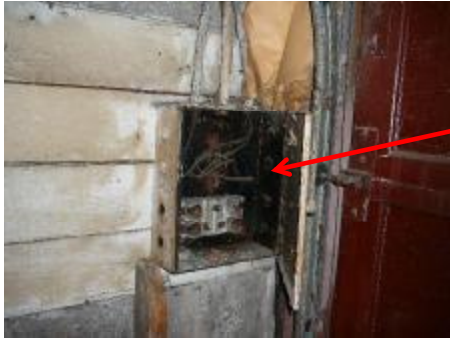
- 24 The electrical box in the north garage is still live/hot, i.e., it still has electricity coming into it. The box should be sealed and closed up or removed.

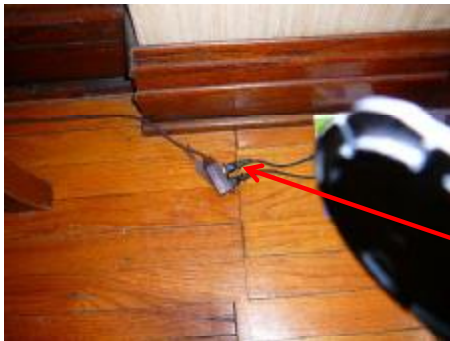
- 25 There are very few outlets in the property. Nearly every outlet I saw had an extension cord w/more outlets or an outlet strip.

Install more outlets in the house when you're remodeling.

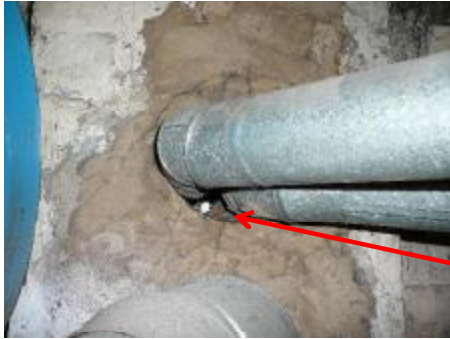
- 27 The water heater flue connectors are not sealed where they enter the chimney. This could allow combustion gas to back into the house which is a life safety hazard. Repair the water heater flue pipes.

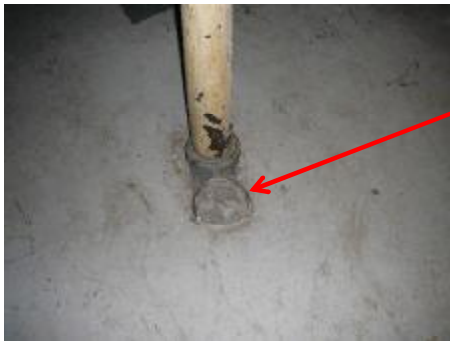
- 28 Older houses often have problems w/the building sewer running to the street. The sewers are most commonly old terra cotta (red clay) tile laid in the mud. The joints between the tiles are not sealed; it is a dry fit bell & hub joint, and it is essentially open. Tree roots looking for water find these joints and penetrate into the tile, blocking drainage and eventually damaging the sewer. When the blockage of damage is substantial, it is often necessary to dig down and replace the damaged section of sewer. This is an expensive & disruptive operation.

Trees in the front yard & the parkway put roots into the sewer. Since you have trees in both the front yard & parkway, I recommend having a plumbing service video-scope the sewer to determine it's condition.

There is no way to know the condition of the sewer without rodding (cleaning) out the sewer and running a videocamera (often called a sewer camera) down the line to examine the tiles. This requires specialized equipment and is beyond the scope of this report. There was no cleanout for the sewer, so rodding or videoscoping will be hard or impossible. You should install a cleanout @ the front yard to facilitate rodding & servicing the sewer to the street.

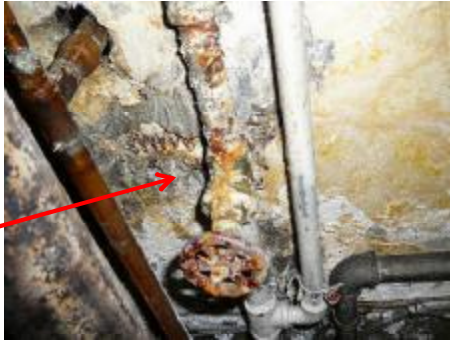
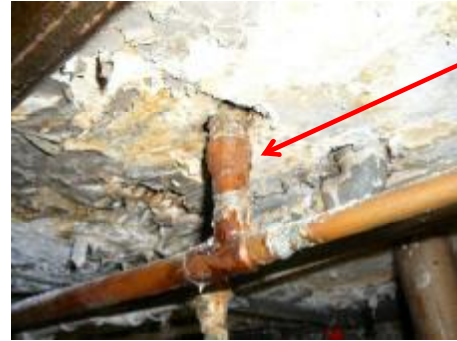
**29** The building supply pipe is almost all original or old galvanized pipe. Water flow fluctuated when multiple fixtures were operated simultaneously; this is caused by corrosion on the pipe interior restricting water flow

There are pipe joints where there is corrosion and stains indicating leaks. The older pipe leaked, and it will leak again.

Basically, the pipe is old and upgrades are overdue; you should plan on replacing the old pipe, the sooner the better.

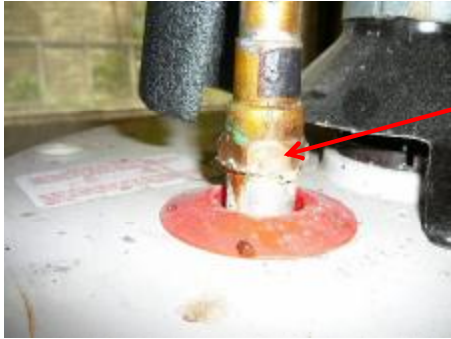
- 31** The right side water heater lacks a dielectric fitting where the pipe is connected to the tank. It's leaking. Repair the water heater connections w/dielectric fittings and proper pipe materials.

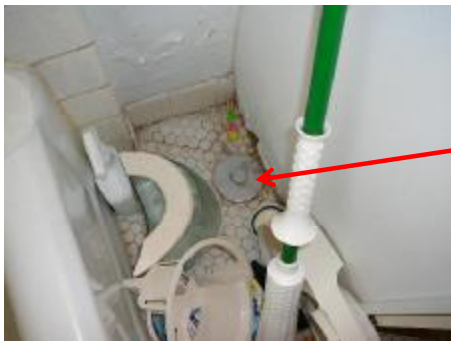
- 33** The first floor bathtub drained slowly. The drum trap is probably clogged w/sludge. Clear out the drum trap to provide drainage from the tub.

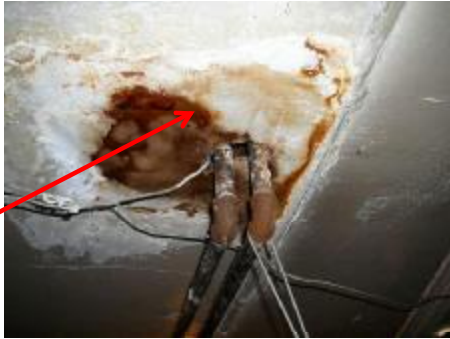
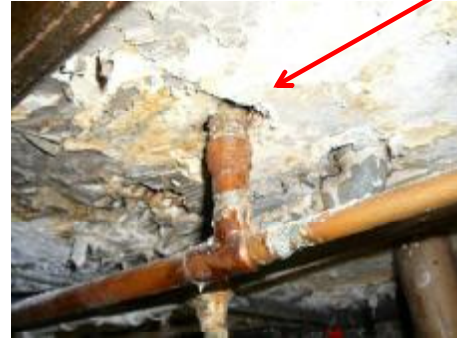
- 34** There are several locations under the wet wall that show indications of leaks. This is another good argument for replacing all the pipe.

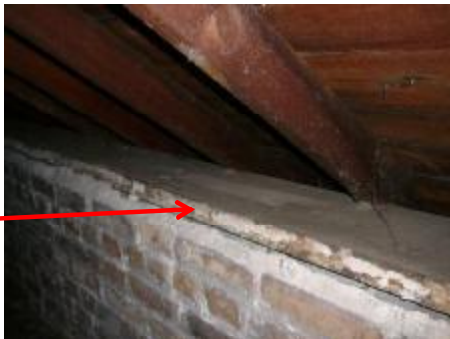
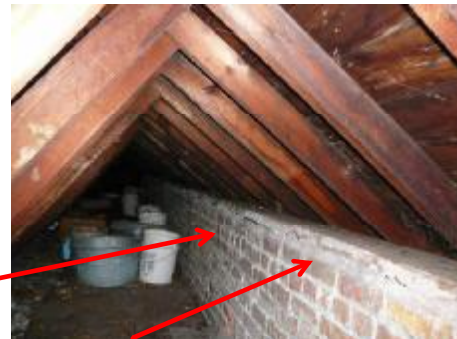
- 36** The roof rafters bear on a sill plate that is lifting and separating due to the lack of rafter ties to hold the base of the rafters together. If this sill plate lets all the way loose, the roof could collapse.

This wouldn't be particularly complicated, but rafter ties would be in a location that would make any future use of the attic space a big problem, as the rafter ties would all be located approx. 3' above the current floor level.

You should get an engineer in there immediately to design a repair to prevent the sills from shifting and possibly causing a failure.

- 46 Have an engineer or architect look at the rafter/sill connection to figure out a repair.

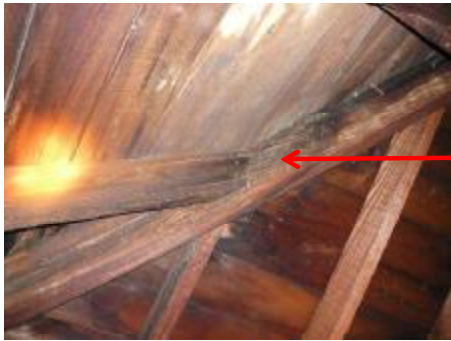
- 37 The NE hip rafter is rotted out or shattered. It should be replaced or repaired w/a new rafter.

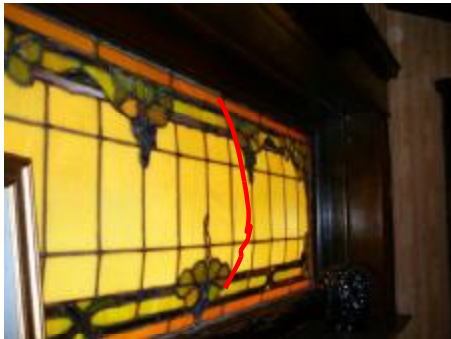
- 40 The leaded glass windows are sagging. They should be repaired, or they will continue to sag and collapse. Repairing leaded glass is expensive.

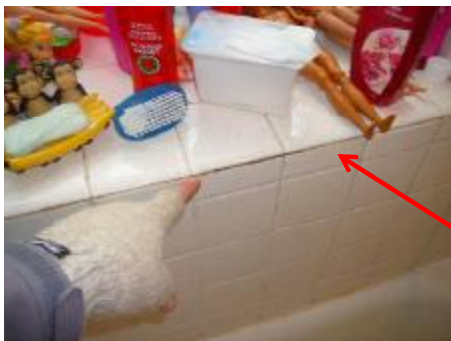
- 41 The tile window sills in both (2) bathrooms are lifting; that means the tile is leaking, soaking water into the underlying wood, and the wood is expanding & lifting the tile. There may be additional damage under the tile in the walls that I can't see. Repair the tile to prevent leaks.

The rest of the tile is in poor condition. It needs repair, reconditioning, or replacement.

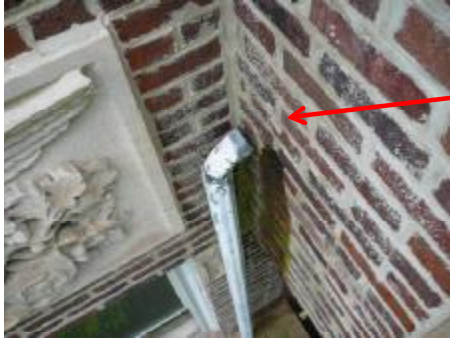
- 42 The front porch downspout is not connected, and water is running down the wall and damaging the wall. Repair the spout.

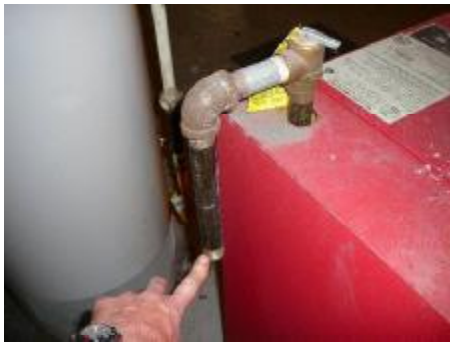
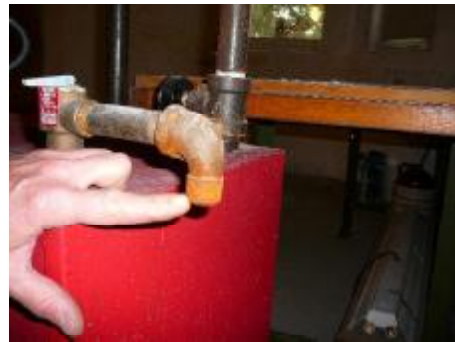
- 43 Both of the temperature and pressure relief valves had threaded fittings on the ends of the pipe. This isn't approved because the pipe could get capped, causing an explosion.

Replace the discharge nipples w/unthreaded pipes.

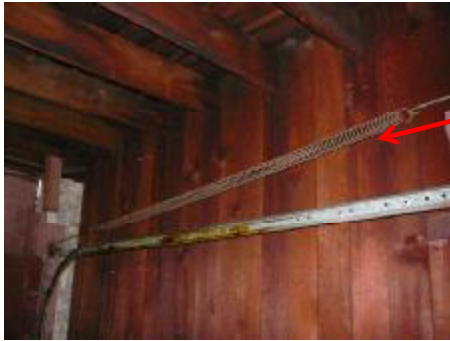
49

The garage door springs lack retaining leashes. If the spring breaks, it could injure someone severely. Install retaining leashes on the garage door opener springs.

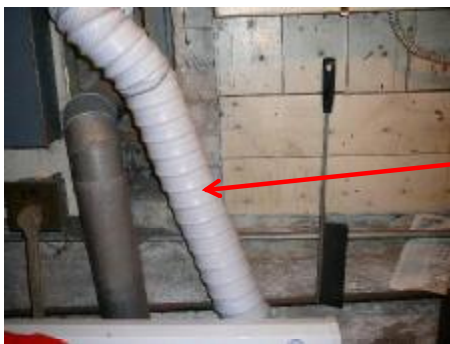
50

The laundry dryer vent is plastic; this material has been shown in several studies to be a fire hazard. Replace the vent duct w/smooth walled metallic ducting.

This has become very common, even w/well documented problems w/the foil type vents. You might want to review the information @ this site....

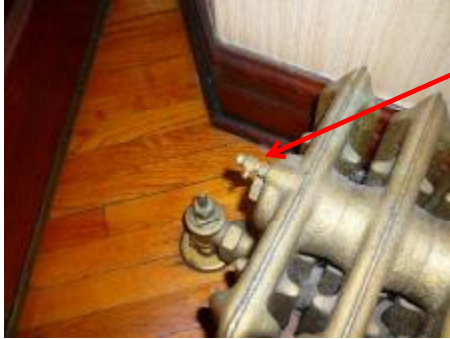
53

There are old bleeder valves on the radiators. These valves are for bleeding air out of the lines so that the radiators heat properly. If any of the radiators fail to warm up, you should open these valves and bleed the air out of them.
