# Kurt Mitenbuler & Associates, Inc.

Inspection Report prepared for:

Aue | 4654 N. Leamington, Chicago, IL 60630 | May 19, 2008

## **Summary Comments**

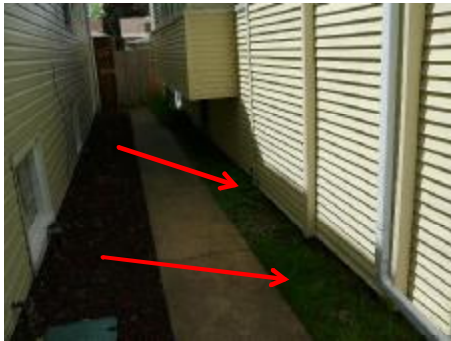
- 1 Grading around the house was inadequate to drain water away from the house and off the property; the yard is flat. Lack of drainage off the property can cause bsmt. water entrance or continuing damp bsmt. conditions; given the damp bsmt. conditions that are readily apparent, you should improve the grading & drainage around the house. Regrade or relandscape the yard, replace sidewalks, extend downspouts, or provide other improvements to drainage to divert water away from the house.

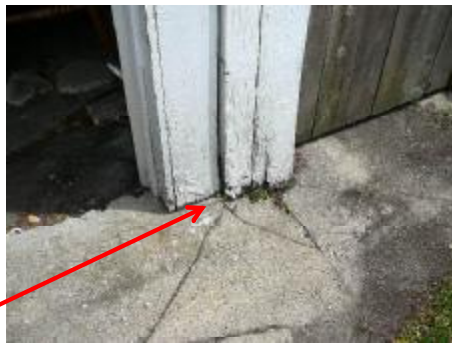
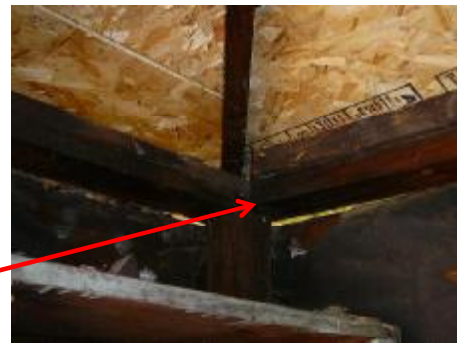
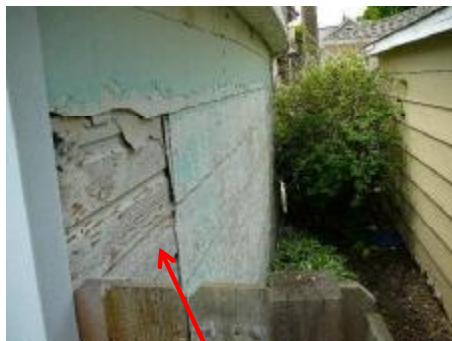
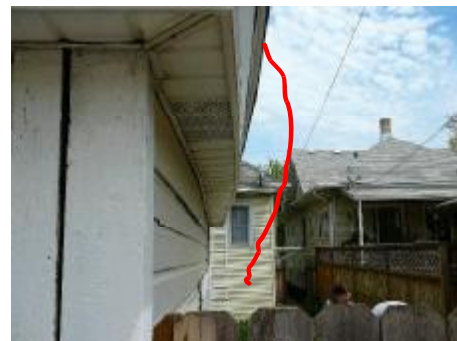
4  
!

The garage has multiple major defects, including but not limited to, very badly leaning and bowed out walls, failed and collapsing rafter ties (that are allowing the walls to bow outward), corner bracing that has failed, siding that is falling off or badly deteriorated, sill plates that are rotten, framing and structural components that are severely undersized and inadequate, and the garage floor is badly broken up and heaved.

In addition, it looks like water from the alley flows into the garage during heavy rains; the alley has portions that are higher than the garage floor.

The garage should be torn down and replaced w/a new structure. I suppose it could be salvaged, but it is very debatable if that is even worth it.

Have a garage contractor look at this and provide cost of replacement or repair.

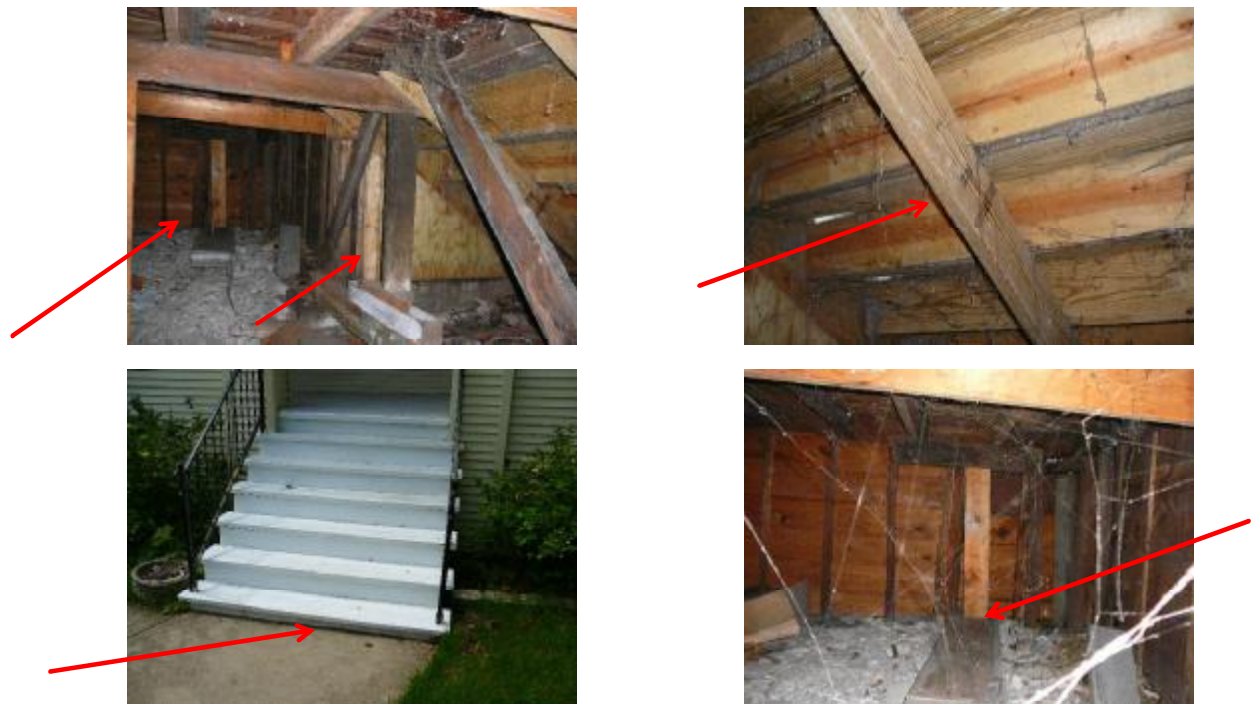
- 5 The front porch has multiple major defects, including but not limited to, rotten and failing corner supports, the stairs are not secured to the structure adequately and could fail catastrophically, repairs performed thus far are hacked together temporary bracing, and the porch crawlspace is full of wood debris that is highly attractive to termites and pests.

The front porch stairs are sagging, have uneven risers, the railings are loose, and they are a hazard to use.

In addition, the front porch is sagging to a degree that makes the floor pitch so much, it's a trip and fall hazard.

The front porch should be rebuilt. Have a contractor look at this and provide a cost estimate for repair or rebuilding.

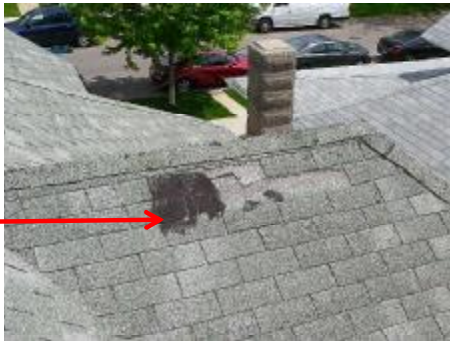
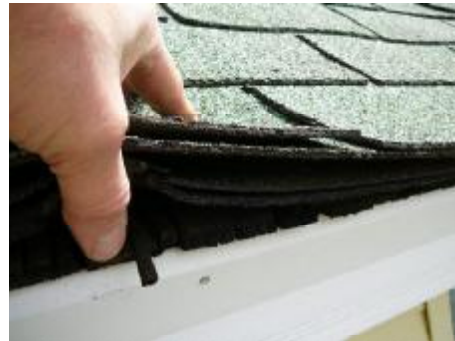
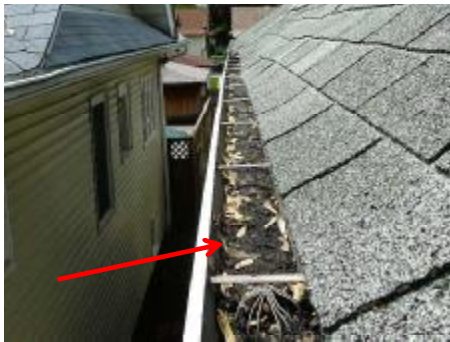
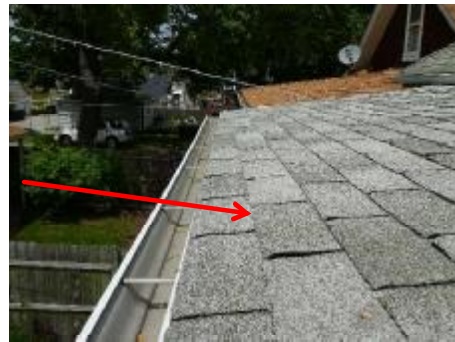
- 10** The roof is in very poor condition w/ multiple major defects, including but not limited to too many roof layers (3), the original cedar is still in place on the old skip sheathing, the shingles are old, worn, and peeling off, flashings are failed, and gutters are filled w/debris and overflowing, there are holes in some the roof valleys, there are no drip caps or overhangs at the rear porch (this will leak), and the rear porch roof has shingles installed on too shallow a pitch (shingles should not be installed on any roof surface <3:12). Basically, the roof is old, and completely worn out.

The original roof is installed over skip sheathing, meaning there are gaps between the underlying roof deck boards. New shingles cannot bridge across this gap, so new plywood will have to be installed over the entire house to allow installation of new roofing materials.

This house needs a complete and total tearoff of all existing materials, new plywood or OSB sheathing installed, and new roofing applied over all roof surfaces. A licensed roofing contractor should reinspect the house to provide cost estimates for replacement.

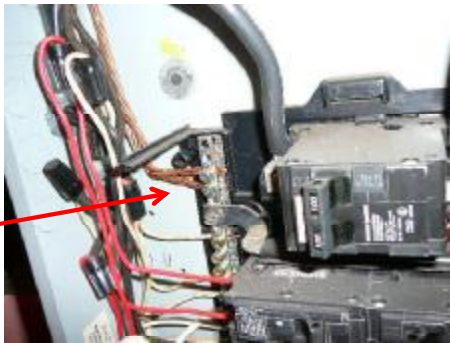
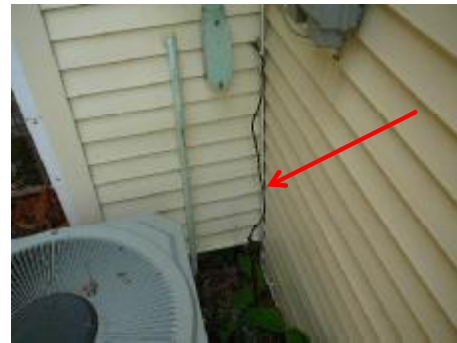
- 16 The system is not grounded adequately. There is only one ground rod. There is no grounding electrode conductor tied to the cold water pipe @ the service entrance as required in Chicago. The grounded conductor is not bonded to the service conduit as required.

What all this means is the (apparently) new service was installed by individuals unfamiliar w/current installation requirements, and that unfamiliarity w/installation standards in Chicago may mean there are other defects hidden in walls and ceilings that I can't see.

You should get the permit and inspection records from the seller to determine if this installation was inspected by the City electrical inspector, and if it meets City of Chicago code requirements.

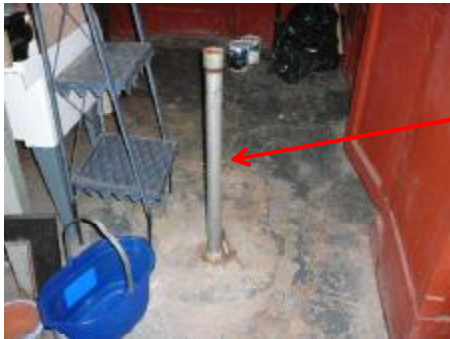
- 18 There is a standpipe @ the bsmt. floor drain. This usually means the sewer has backed up, and the pipe is a means of minimizing the flooding out over the floor. The sewer should be rodded and videoscoped to determine it's condition.

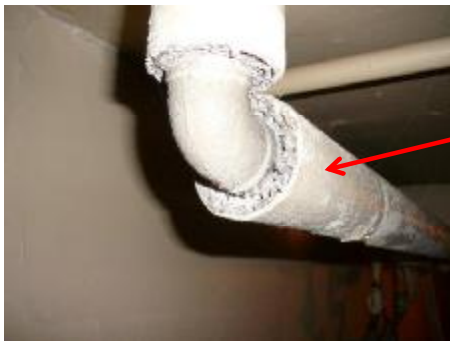
- 19 There is asbestos insulation on the plumbing pipes in the bsmt. There are several open end caps and areas of exposed material. The asbestos insulation should be encapsulated or removed by a licensed asbestos abatement contractor.

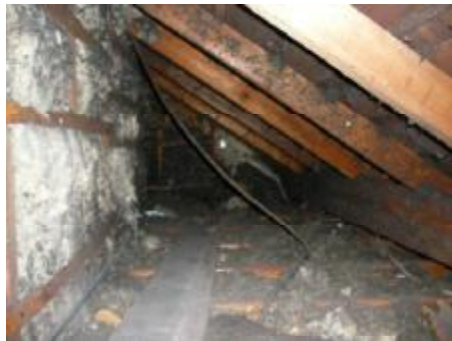
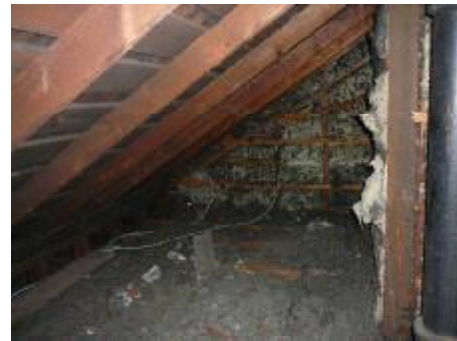
- 24 The house is minimally insulated. There is very little, or no, insulation in the attic, and the rear porch crawlspace is poorly insulated. This will greatly effect energy costs & general heating & cooling in the house. There is no way to retrofit insulation without tearing everything out & starting over.

Check the heating and cooling bills to determine the energy costs for this property.

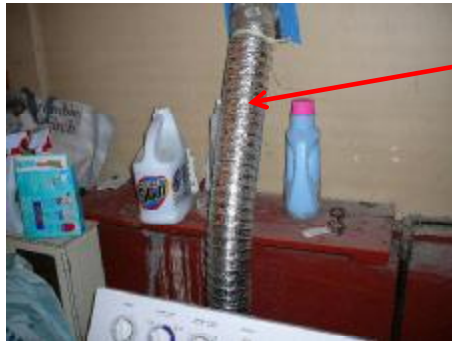
- 31 The laundry dryer vent is plastic foil; this material has been shown in several studies to be a fire hazard. Replace the vent duct w/smooth walled metallic ducting.

This has become very common, even w/well documented problems w/the foil type vents. You might want to review the information @ this site....

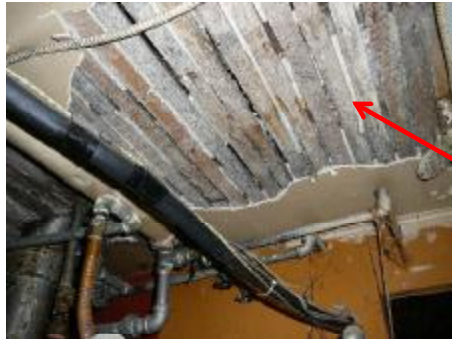
- 33 Several areas of bsmt. plaster ceiling are falling down. This is a hazard. Repair all the collapsing plaster.
